# Manhole Inspection Summary

## Manhole # S110O1015MH

Insp Date: **5/30/07 10:37 AM**

**Location** Address: **4854 PIMLICO RD**

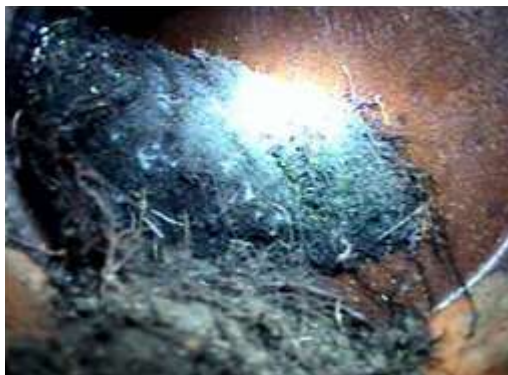
Defect 1

POSSIBLE I5 ROOT INFILTRATION

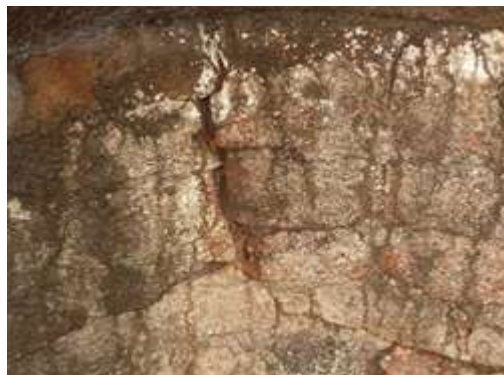
Defect 4

Condition: ☐ Sound ☒ **Cracked** ☐ Leaks

CRACKED FRAME

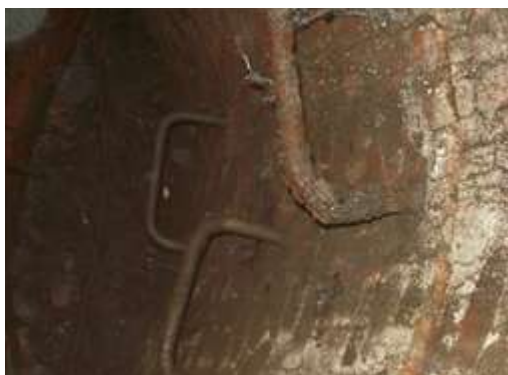
Defect 3

Count: **3** Missing: **0** ☒ **Corroded**

CORRODED STEPS

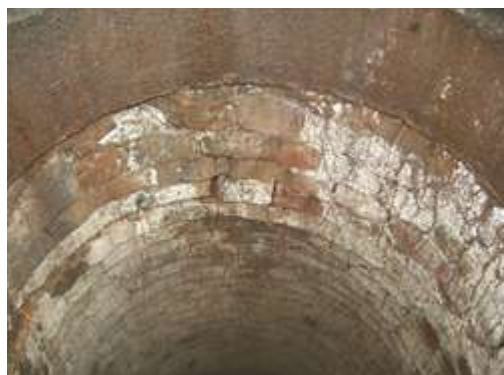
Defect 5

Condition: ☐ Sound ☒ **Cracked** ☐ Root Intrusion ☐ Loose Brick ☐ Deteriorated

CRACKED CORBEL

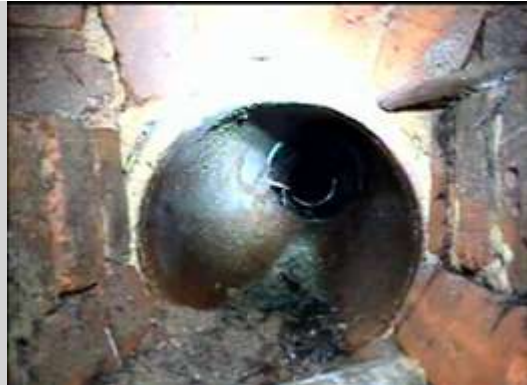
12 O'Clock Outflow

Deposits: ☐ None ☐ Mud ☐ Sludge ☒ **Debris** ☐ Grease

Silt Depth: **0.25** (in.) Deposits Extent: **Light**

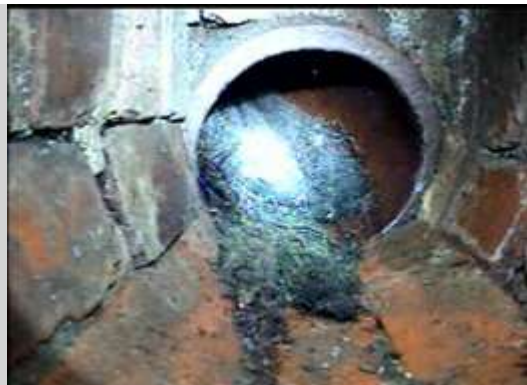
5 O'Clock Inflow

Deposits: ☐ None ☐ Mud ☐ Sludge ☒ **Debris** ☐ Grease

Silt Depth: **4** (in.) Deposits Extent: **Heavy**

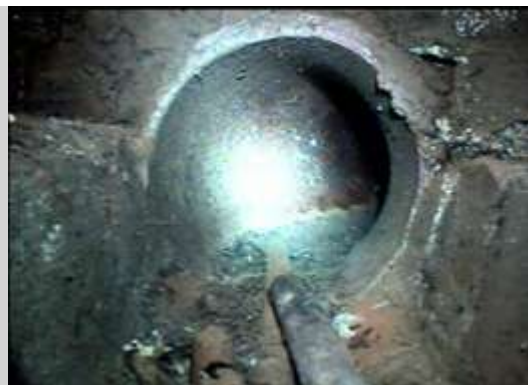
9 O'Clock Inflow

Deposits: ☐ None ☐ Mud ☐ Sludge ☒ **Debris** ☐ Grease

Silt Depth: **0.5** (in.) Deposits Extent: **Light**
